This document is a tool to help ensure appropriate due diligence has been taken prior to site clearance/works. Evidence is required to demonstrate all tree clearance has been suitably reviewed and can be justified.

Name	Signature		Date
Application made by:	MDJV			15/05/2024
Location (Sector/Site Name):	Camden Construction Skill Centre			
LAA/LAP/Site Reference	N/A			
Work Package number:	N/A			
Date of Tree Panel:	Camden Construction Skill Centre			
Site Description:	Camden Construction Skill Centre			
Reason for clearance:	Removal of a broken branch for safety reasons.			
Drawing Reference No.:	N/A but annotated photographs as below section			
	Yes	No	N/A	Comments
Has the Stage 1 Survey been completed and logged on the Register	X			
	Yes	No	N/A	Comments
Has the Stage 2 Survey been completed with retention and protection measures logged on the Register			X	
Have all practicable means to negate need for works to tree been investigated? Please provide details	Yes, the proposed works are undertaken for safety reasons and will only remove the branches that are already broken.

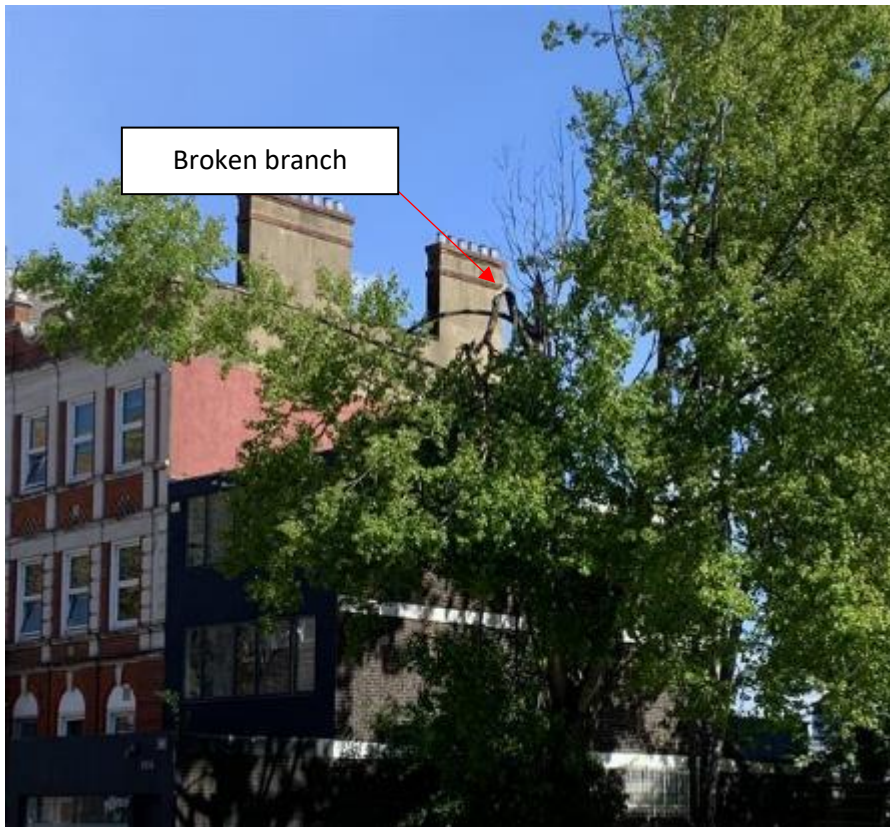
Photo1: Photo illustrating the point where the branch is broken.

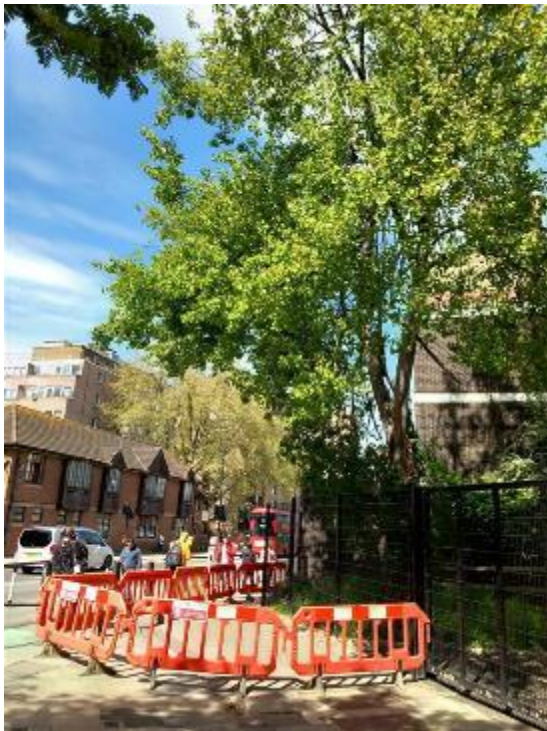
Photo 2: Exclusion zone and hanging branch from below
