LBC Tree Panel Review of Works

Name		9	Signature		Date					
Application made by:						19/02/2025					
Location (Sector/Site Name):		Euston Approaches – 22 Park Village East Asset protection									
LAA/LAP/Site Reference		Grid Reference TQ 28803 83380									
Work Package number:		Asset protection design APD-ESCT-02									
Date of Tree Panel:		19/02/2025									
Site Description:		22 Park Village East									
Reason for clearance:		As part of Skanska Costain STRABAG (SCS) asset protection mitigation works, additional ground investigations are required in the vicinity of the tree and it's RPA. The headroom required is approx. 3m, the canopy currently hangs low over the site entrance and therefore may be impacted by machinery entering the working area. It is therefore recommended that localised canopy reduction and pruning is undertaken to facilitate access of the borehole rig, and an arboricultural specialist is in attendance to supervise activities within the RPA.

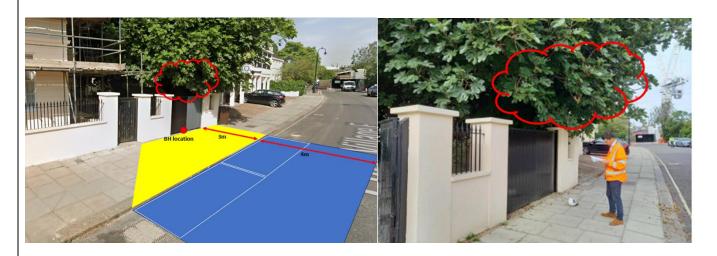
Site Sketch/ Diagram / Photos:

Tree ID	Species	Easting	Northing	leight (m)	DBH (cm)			d (m)		Trunk Cat	Age	Exceptional Tree	ERC	TPO	Main Cat	Sub Cat	Status	RPA Radii (m)	Description
T01	Fig	528792	183390	12	440	4	5	4	5	Single	М	Υ	20+	No	В	1	Retain	5.3	Located inside a private front garden with hardstanding block paving covering almost the entirety of its RPA. Growing very close to brick boundary wall and causing cracks to develop as the stem slowly expands. Spreading canopy with signs of previous management; several endloaded branches noted being supported by cable bracing.
