Name	Signature		Date
Application made by:	MDjv			20/06/2023
Location (Sector/Site Name):	Interim Taxi Rank			
LAA/LAP/Site Reference	LP00862_T_F120 and LP00861_T_F107			
Work Package number:	N/A			
Date of Tree Panel:			20/06/2023	
Site Description:	Interim Taxi Rank			
Reason for clearance:	<p>In order to have the lampposts lowered to instal the lamps, we need to trim some branches around two lampposts and have the clearance necessary so the posts can be lowered and reset without hitting the tree branches.</p> <p>In addition, there is a current amount of obstructive foliage obscuring the luminaires, so the leaves will not give a good light spread or provide a suitable LUX reading.</p> <p>See below sketches with the demarked areas to be trimmed.</p>

Site Sketch/ Diagram / Photos attached

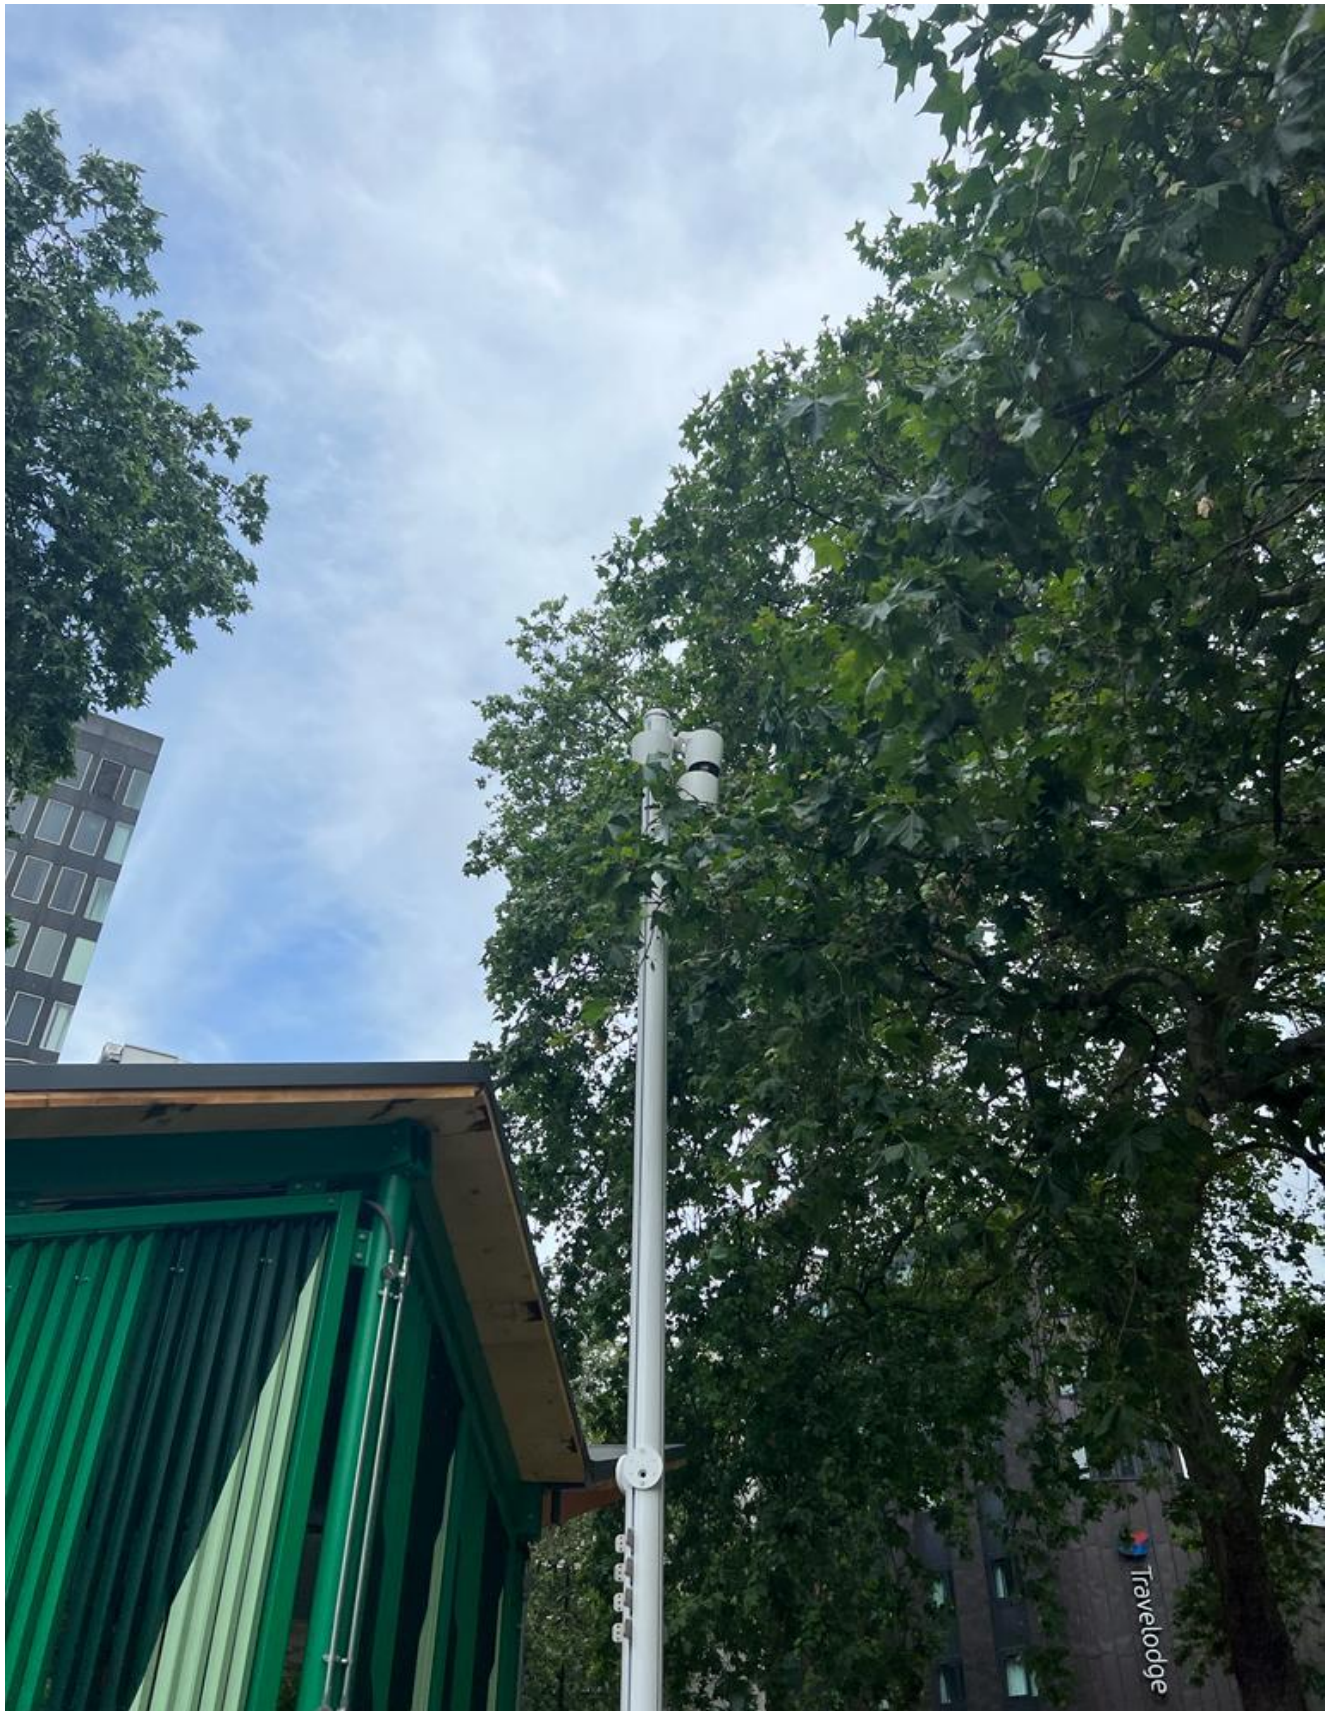
Photograph No 1: General overview of the lamppost with branches and foliage obstructing the lights on tree LP00862_T_F120.

No trees identified for removal. Request to prune the branches indicated above, from trees LP00862_T_F120 and LP00861_T_F107 under Arboricultural Watching Brief supervision.

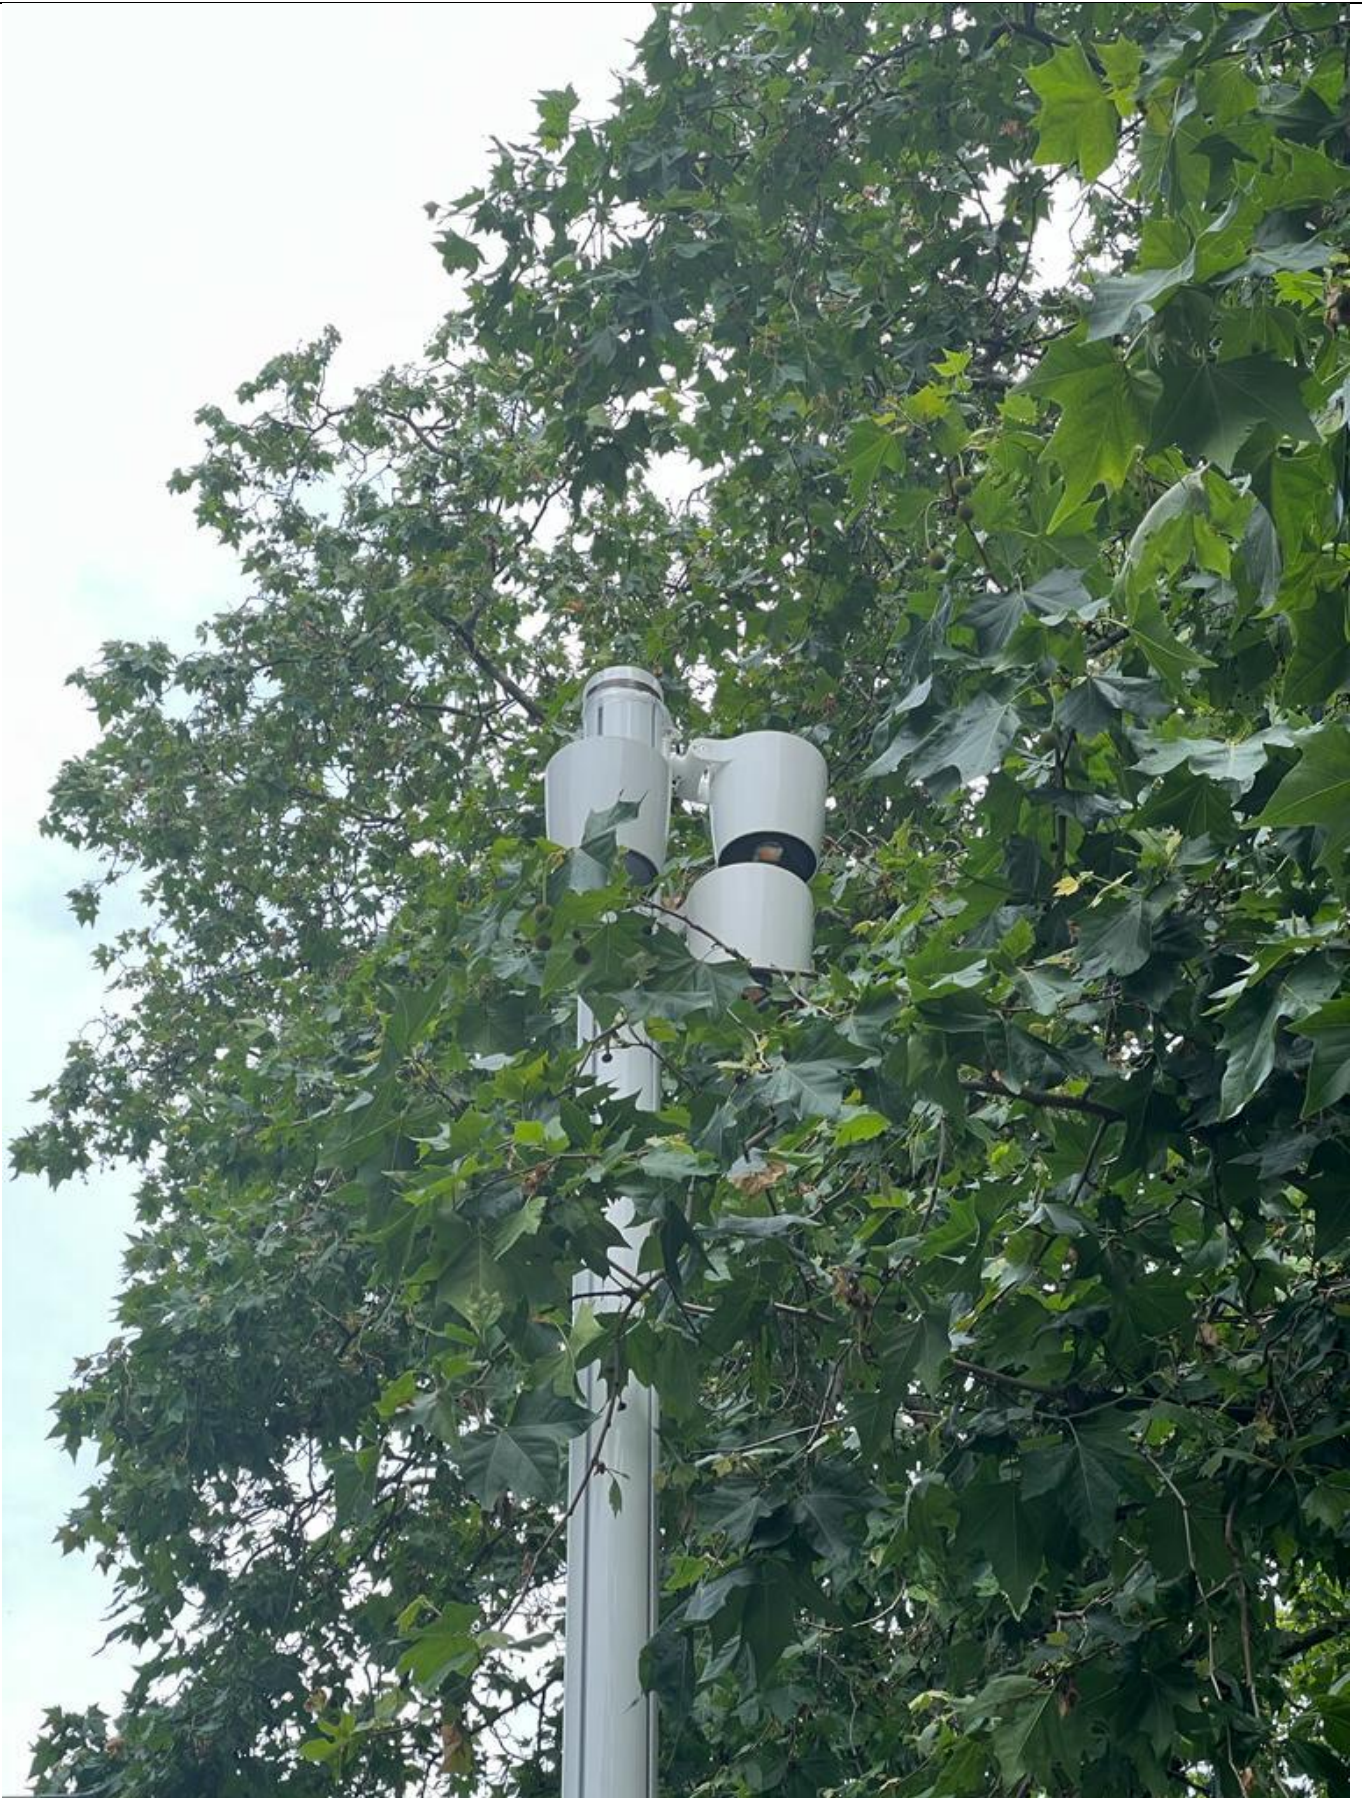
Photograph No 2: Zoom in view of the lamppost with branches and foliage obstructing the lights.

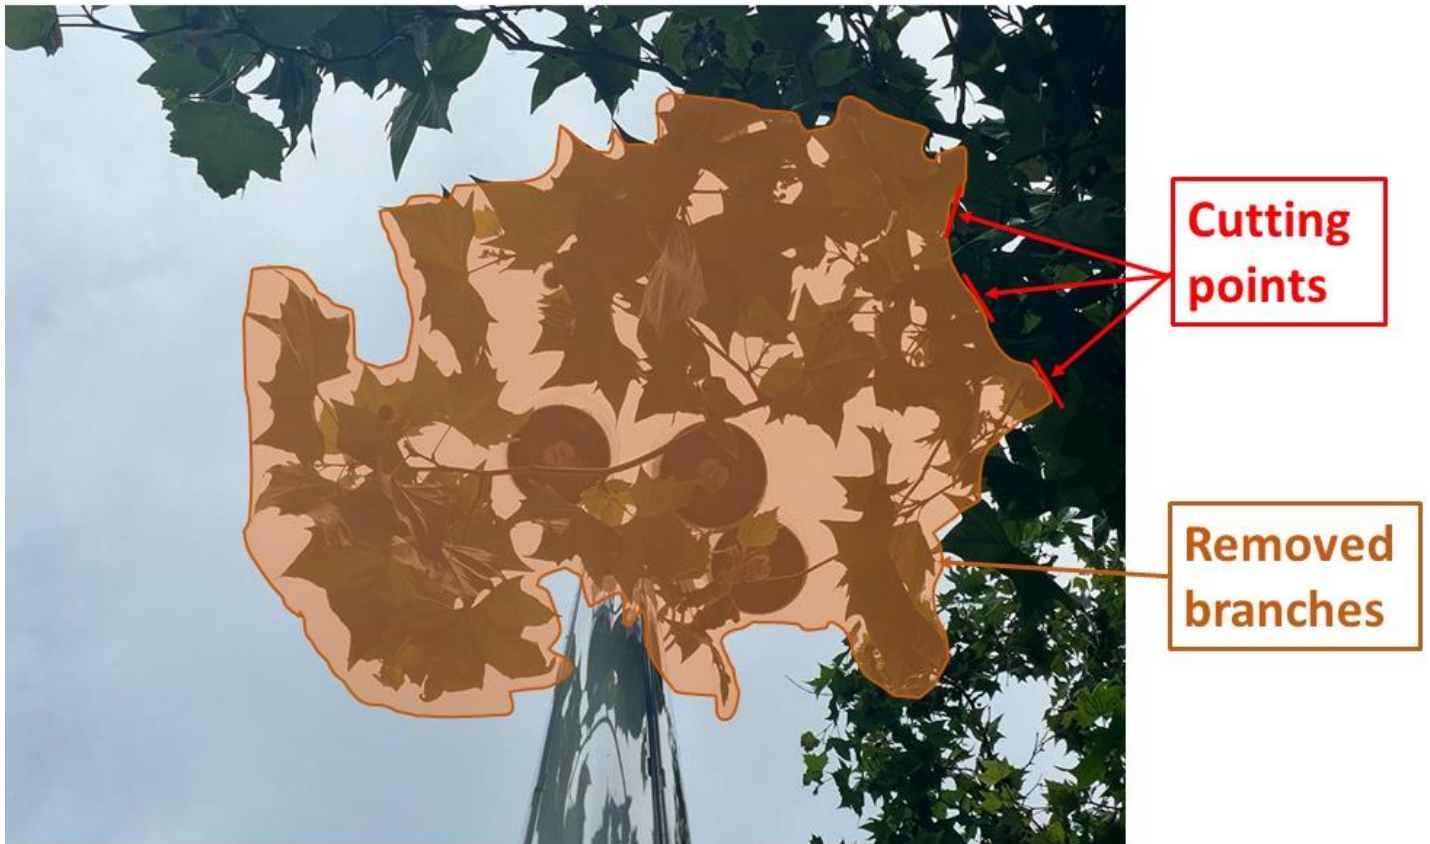
Photograph No 3: Proposed cutting point for the branches.

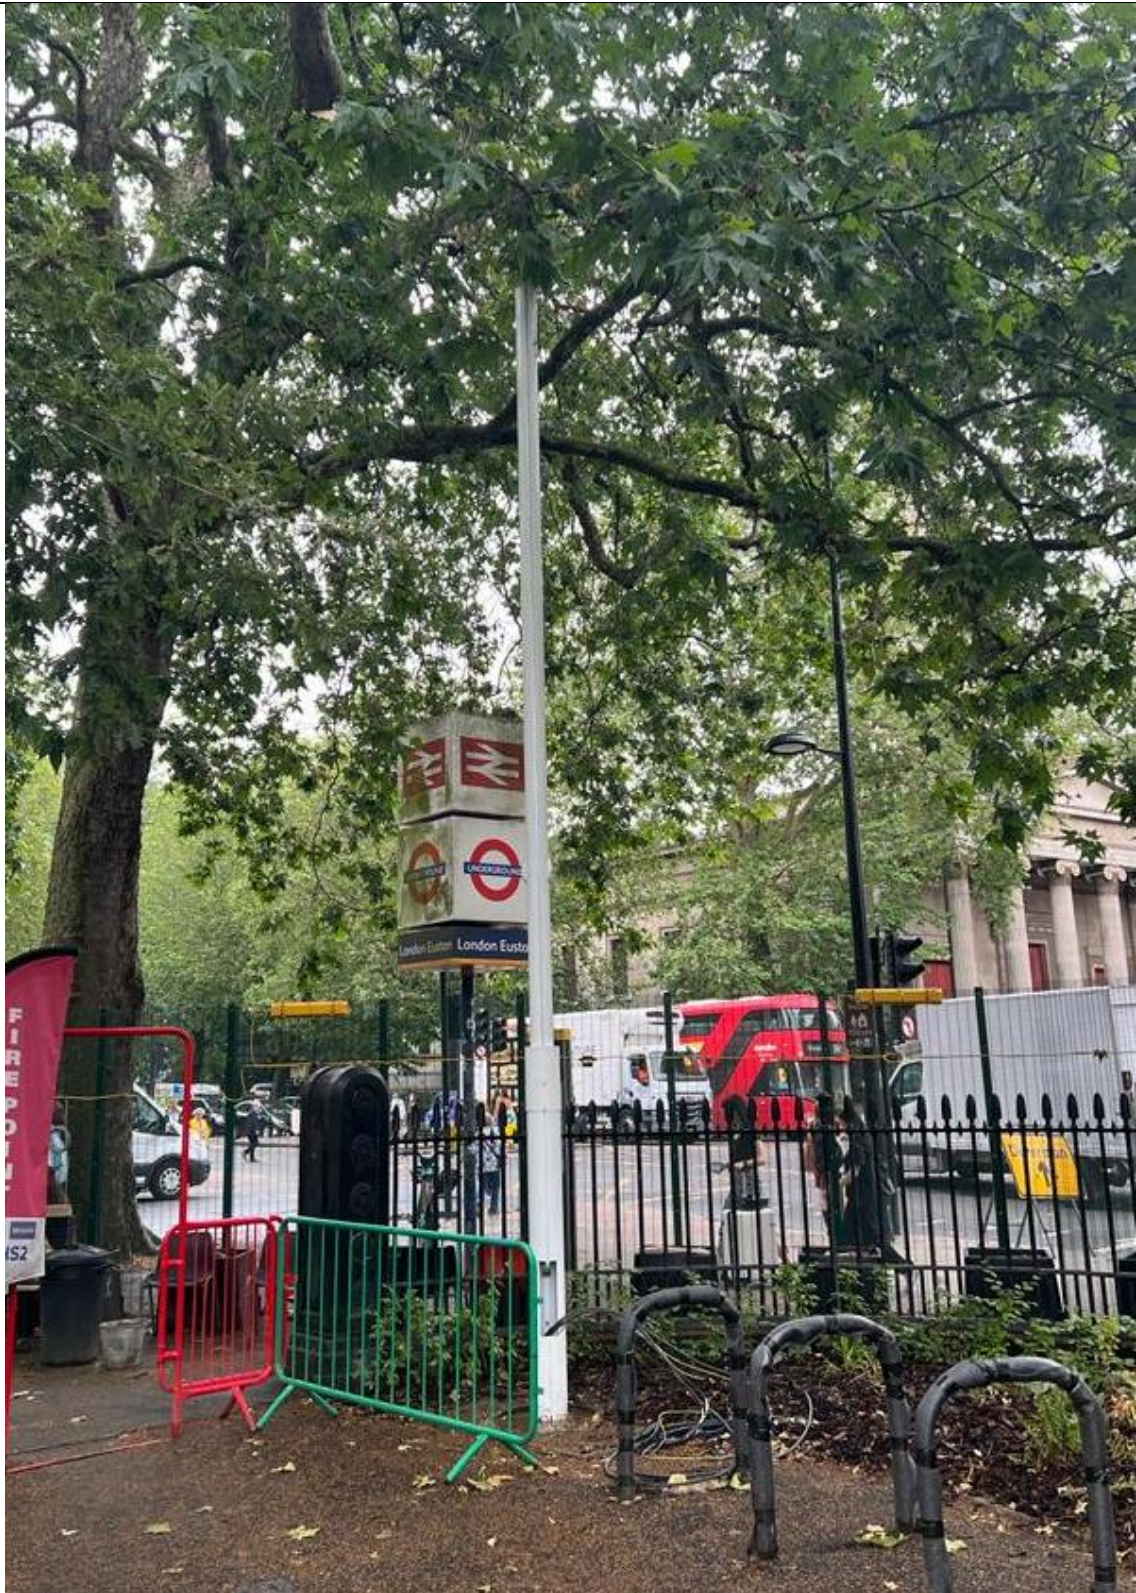
Photograph No 4: General overview of the lamppost with branches and foliage obstructing the way to lower the post on tree LP00861_T_F107.

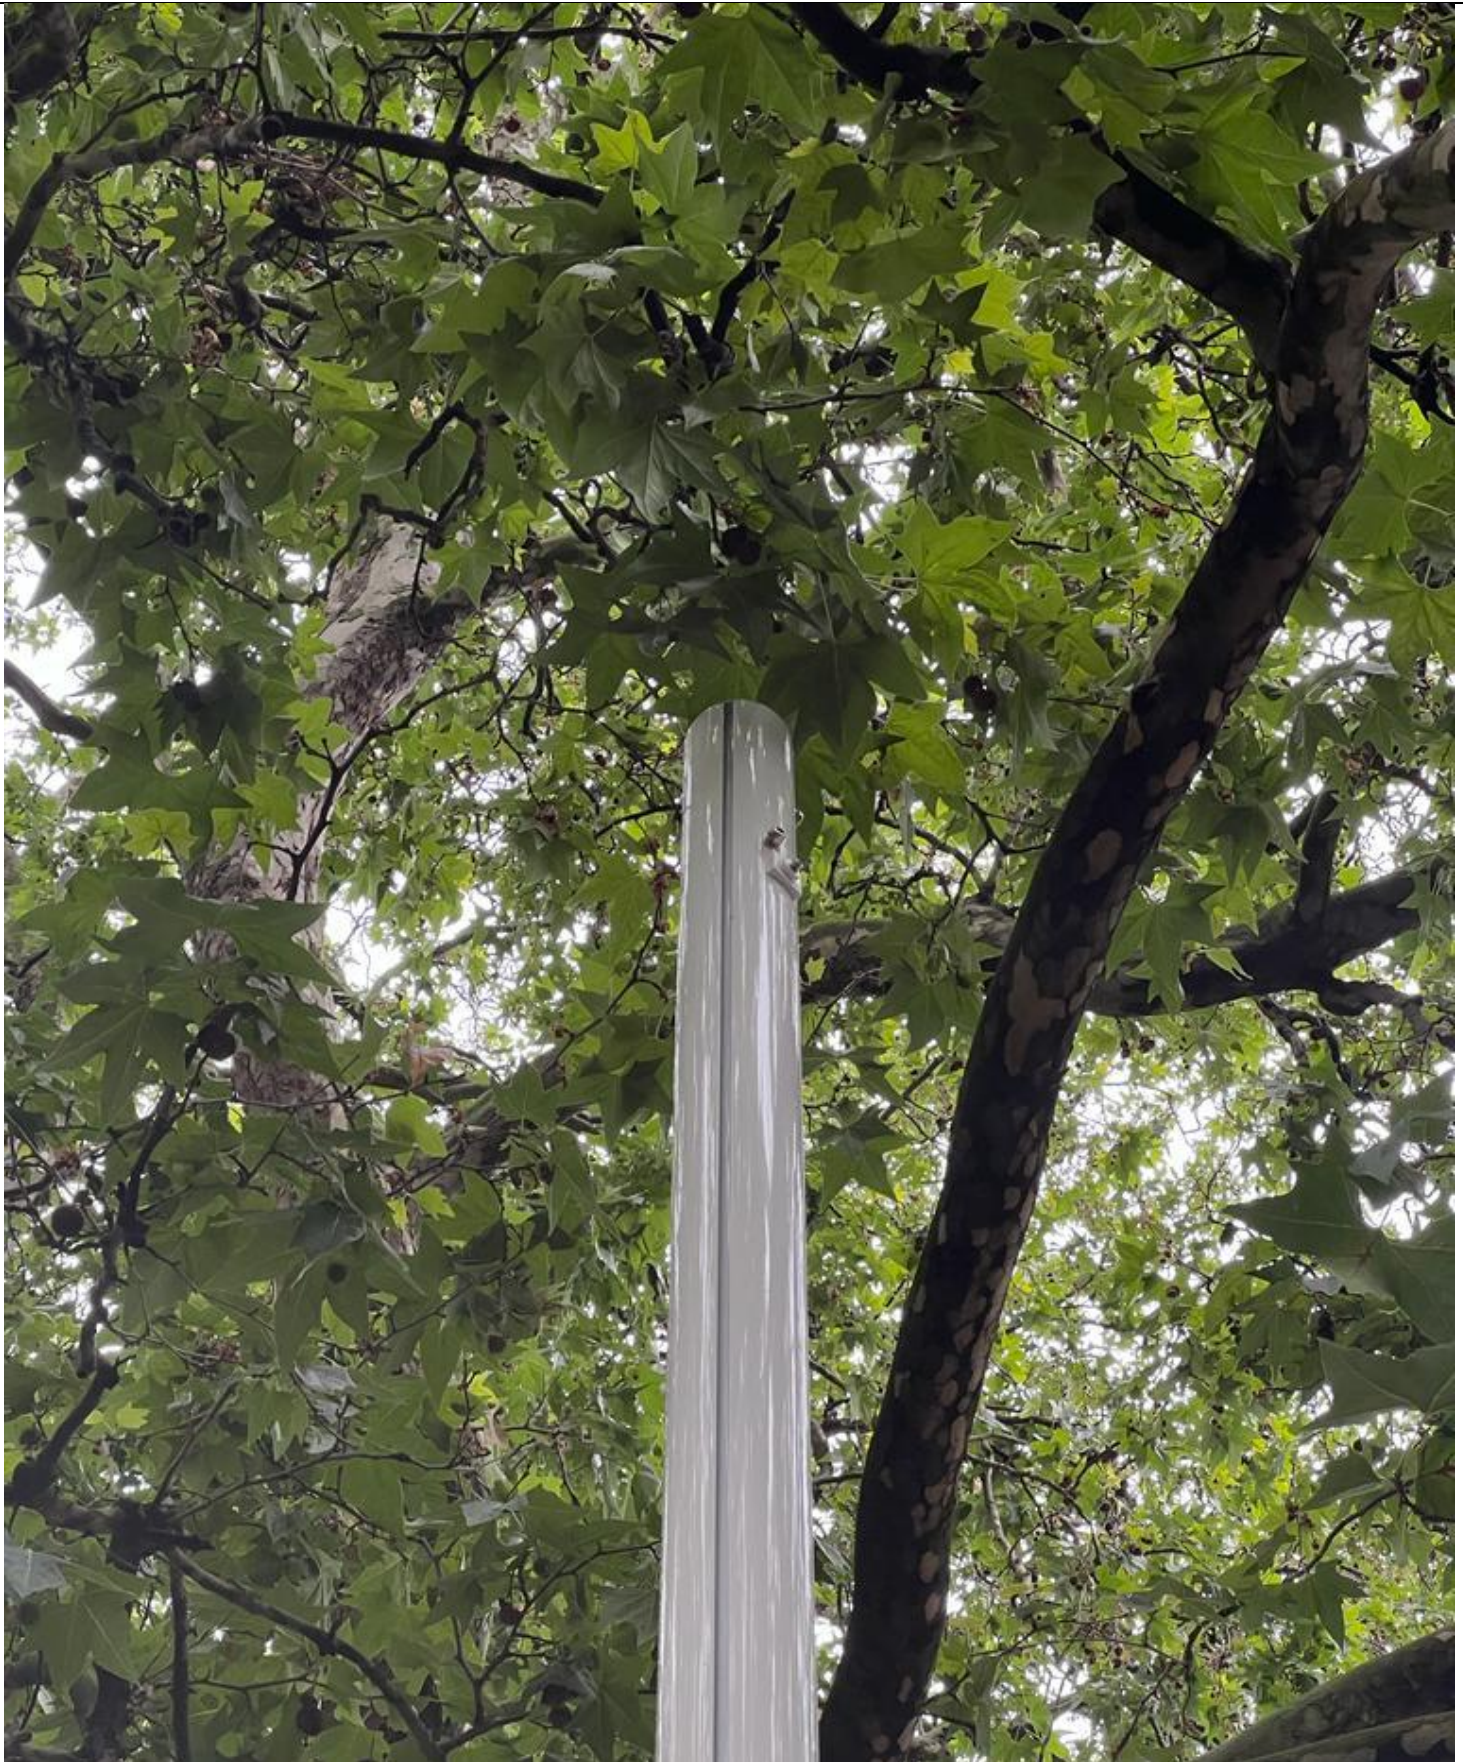
Photograph No 5: Zoom in view of the lamppost with branches and foliage obstructing the lights.

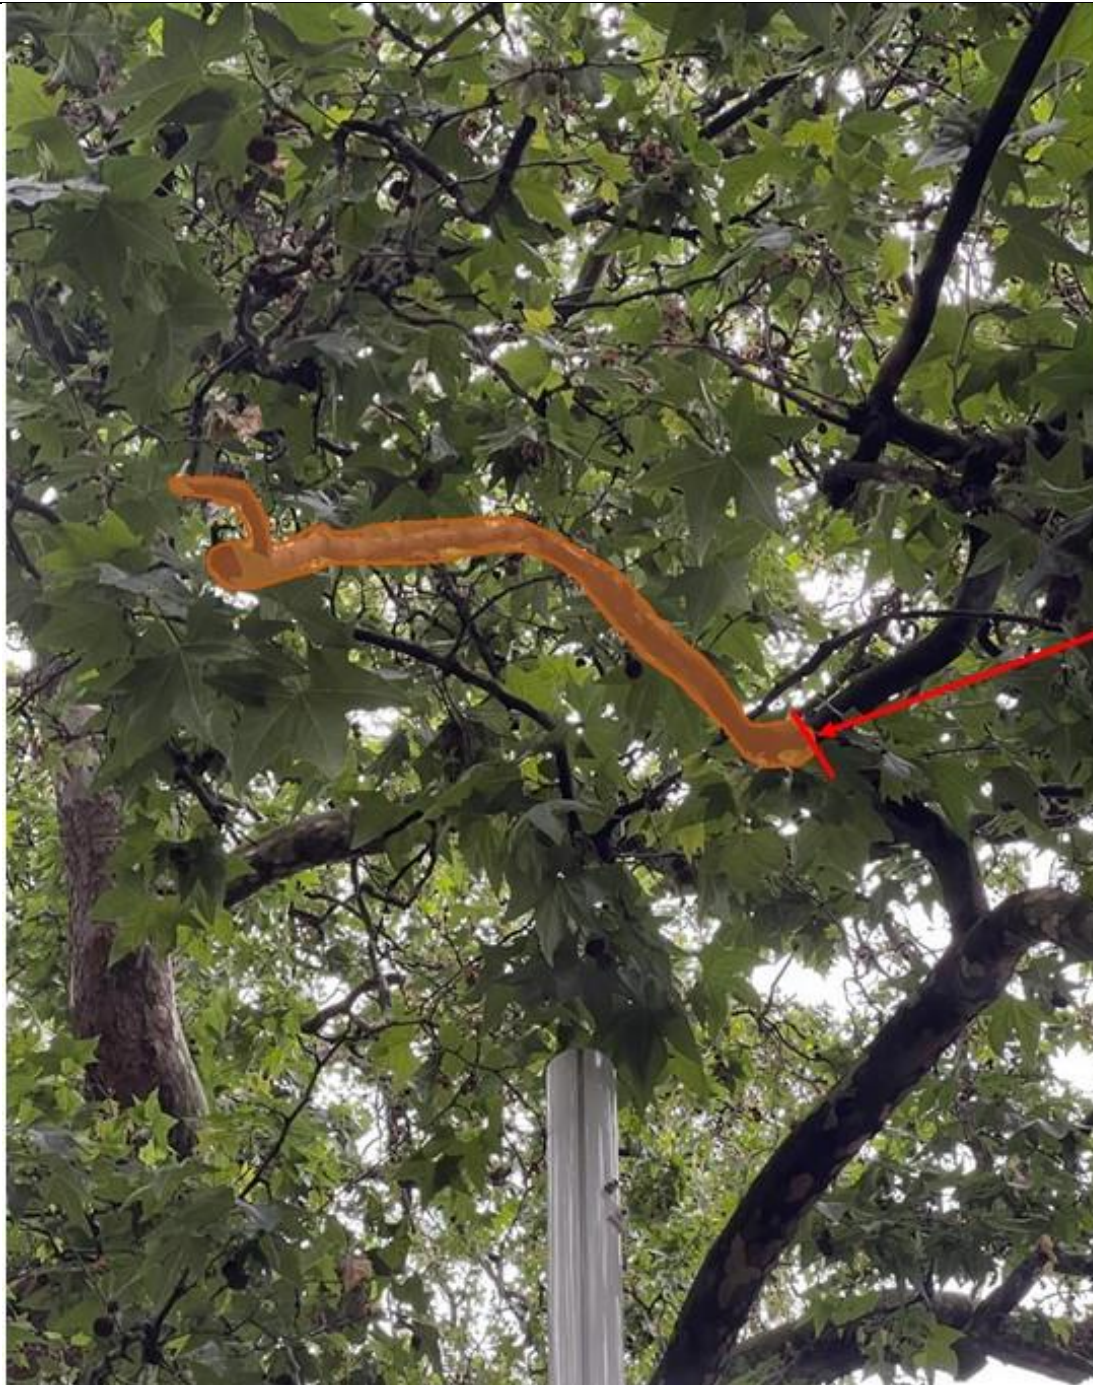
**Cutting
point**

Photograph No 6: Proposed cutting point for the branches.

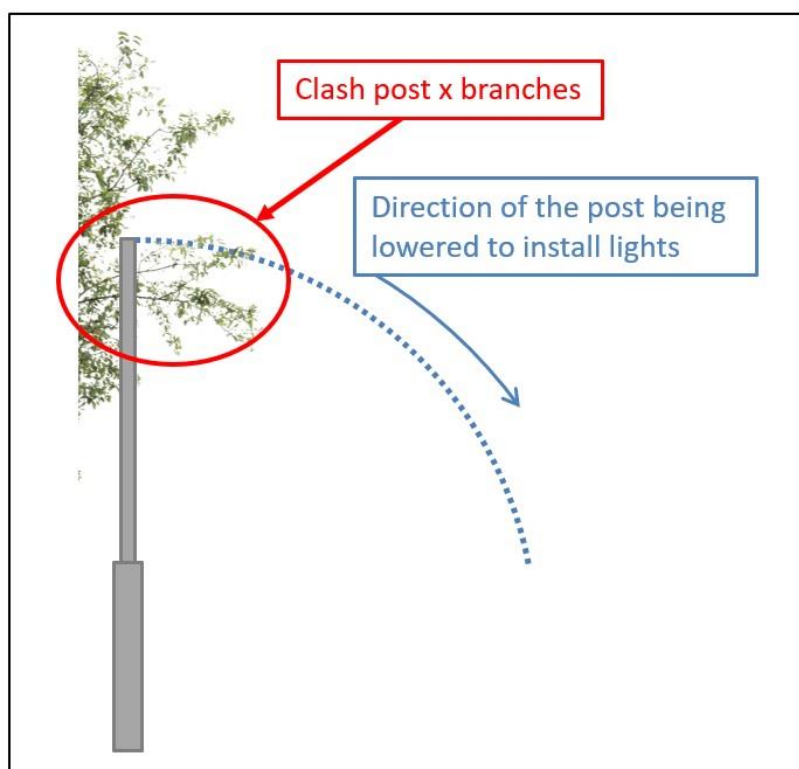
Drawing No 2: Clash post and branches sketch

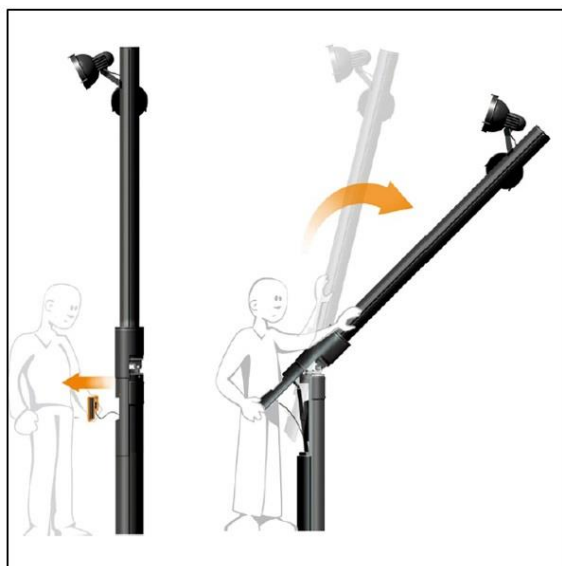
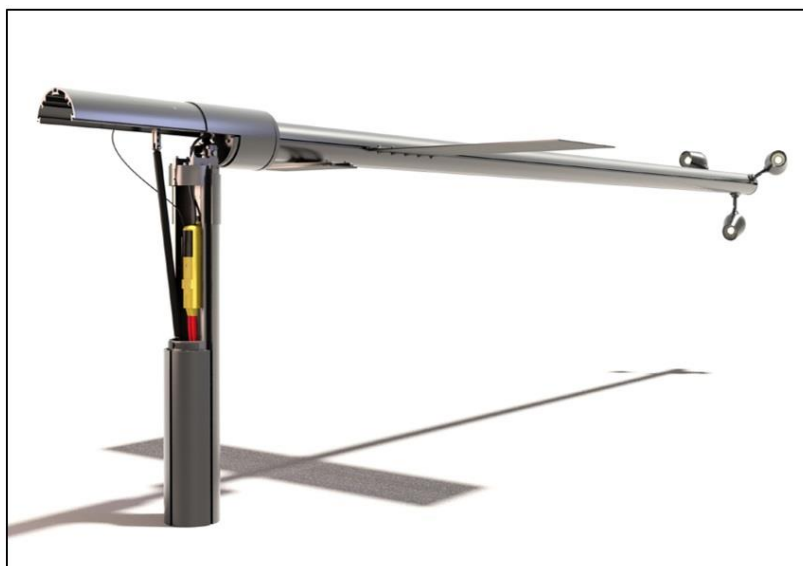
Drawing No 3: Lamppost lowered sketch
