Name	Signature			Date
Application made by:	SCSJV				06/07/2023
Location (Sector/Site Name):	Park Village East, Euston Approaches, HS2				
LAA/LAP/Site Reference	LAP05459				
Work Package number:					
Date of Tree Panel:	Via correspondence				
Site Description:	Park Village East				
Reason for clearance:	The purpose of the pruning is to reduce weight pressure on the planter

Trees Affected and Scope of Works:

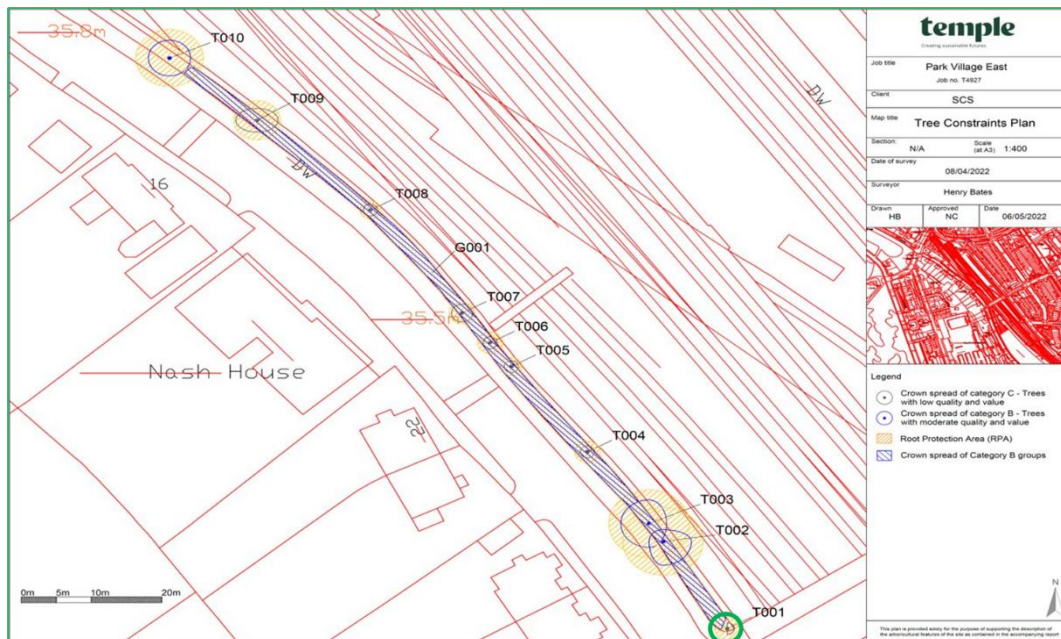
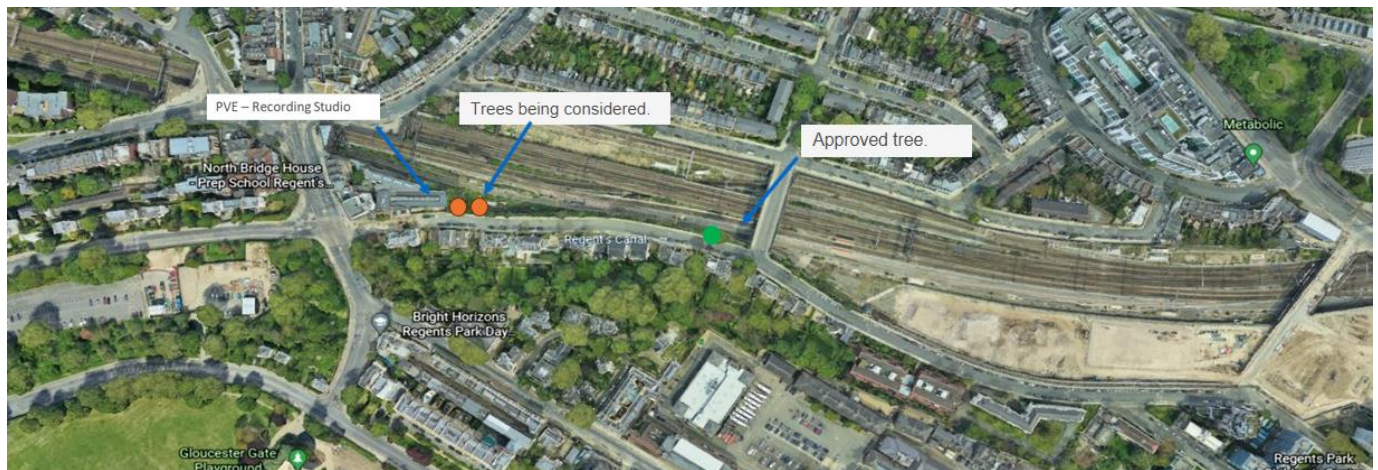
Drawing Reference No:	Park Village East Tree Stage 1 Survey				
	Yes	No	N/A	Comments	
Has the Stage 1 Survey been completed and logged on the Register	X				
	Yes	No	N/A	Comments	
Has the Stage 2 Survey been completed with retention and protection measures logged on the Register	X				
Have all practicable means to negate need for works to tree been investigated? Please provide details	<ol style="list-style-type: none"> 1. The overgrowth of the trees is causing an obstruction and thereby a health and safety issue to people and machinery within the area. For example, people are stepping off the pavement onto the road when walking near the trees to avoid the branches. 2. Branches overhang the wall into the construction site and need to be removed to reduce safety risk. 3. The water and weight demand of the trees is currently too large and risks causing damage to the planter or adjacent wall.

Tree ID	Species	Easting	Northing	Tree group area (ha)	Height (m)	DBH (cm)	Spread (m)				Trunk Cat	Age	Exceptional Tree	ERC	TPO	Main Cat	Sub Cat	Status	RPA (m)	Description
							N	S	E	W										
T010 (Tree A on presentation)	Ash (Fraxinus excelsior)	528765	183446	N/A	7	40	3	3	3	3	single	EM	No	10+	No	8	2	Works to asset	4.8	Ivy clad to crown break and has various materials stacked in the raised planter within the tree's RPA. Has been pruned back carefully to British Standards on the south section away from the new compound; wounds occluding well. Sever and remove ivy once dead then re-inspect main stem. Remove all materials stacked in the raised planter within the tree's RPA that are not on hardstanding.
T009 (Tree B on presentation)	Sweet chestnut (Castanea sativa)	528778	183438	N/A	6.5	27	2	2	3	3	single	SM	No	10+	No	C	1	Retain	3.2	Moderate amount of deadwood throughout canopy.
T002 (Tree C on presentation)	Sycamore (Acer pseudoplatanus)	528836	183362	N/A	9	30	2	4	4	2	multi (2-5)	EM	No	20+	No	C	2	Works to asset	3.6	Included bark at base, dominated by adjacent sycamore to the west creating prominent lean and crown bias to the east. Crown reduce by 1-2m.
