Drawing Reference No:	AMPHILL TOWER ESTATE ABORICULTURAL STAGE 2 UTILITIES CONSTRUCTION PHASE 1 - HAMSPTEAD ROAD BRIDGE			
	Yes	No	N/A	Comments
Has the Stage 1 Survey been completed and logged on the Register	X			
	Yes	No	N/A	Comments
Has the Stage 2 Survey been completed with retention and protection measures logged on the Register		X

Two trees (T001 and T002) and 3m section of hedge (H001) along the Hampsted Road perimeter, plus a tree (T004) within the central grassed of the Ampthill Estate grounds.

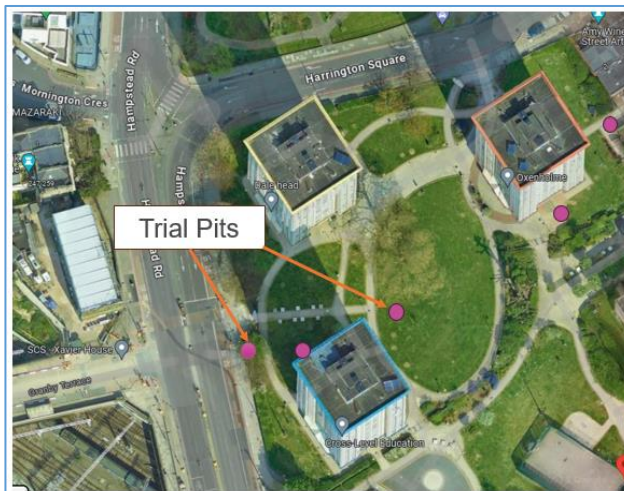
Cable route from Hampstead Road to Gillfoot substation to provide power to substation and associated interaction with Tree Protection areas.

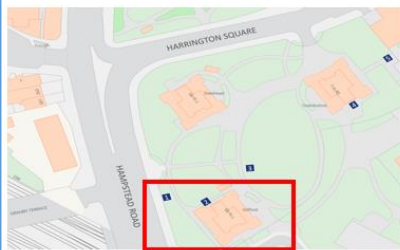
Description	Photograph
<p>T001 - Common beech</p> <p>Category B – Providing moderate visual amenity value.</p> <p>Arboricultural Recommendation: Retain – Works within Root protection area to be undertaken with hand tools and under arboricultural supervision.</p>

T001: Retained, but works in root protection area to be undertaken with hand tools and under arboricultural supervision.

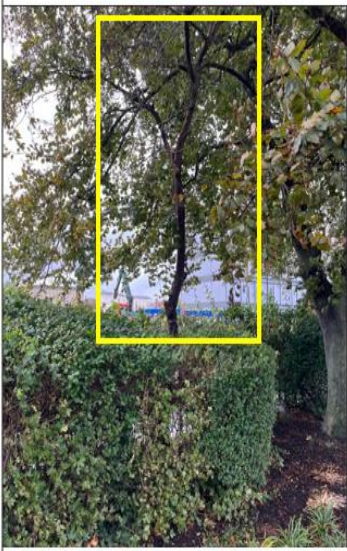
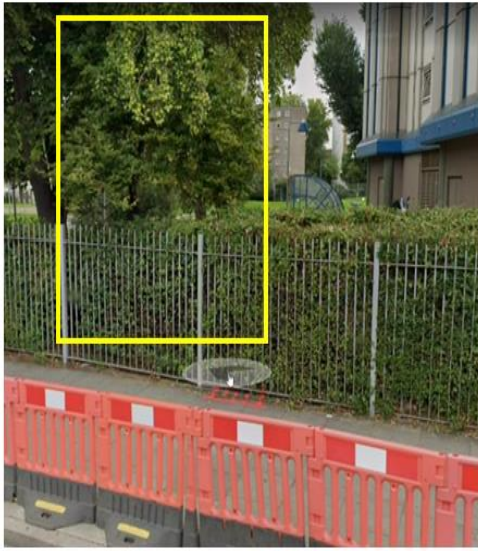
Description	Photograph	Photograph
<p>T002 – Apple</p> <p>Category U – found to be moribund</p> <p>Arboricultural Recommendation: Possible Removal</p> <p>SCS Proposal to explore: Reinstatement of tree in Ampthill Estate at earliest opportunity</p>

T002: Retained, but works in root protection area to be undertaken with hand tools and under arboricultural supervision, It is not anticipated to remove this tree as a result of the trial hole location, however, due to its current condition should during the progression of the works should it be recommended by the arboricultural supervision that the activity is likely to further impact the mortality of the tree it may require to be removed.

Proposal Endorsed with conditions			
Conditions	<p>SCS are to replant a tree in the site of any tree removed as part of the trial hole work described above. Size of replacement tree to be agreed with HS2</p> <p>SCS are to replant any hedge removed as part of the trial hole work described above using the same species and ensure protective fencing (such as chestnut pale) is installed to protect the new planting and prevent the area becoming a short cut</p>

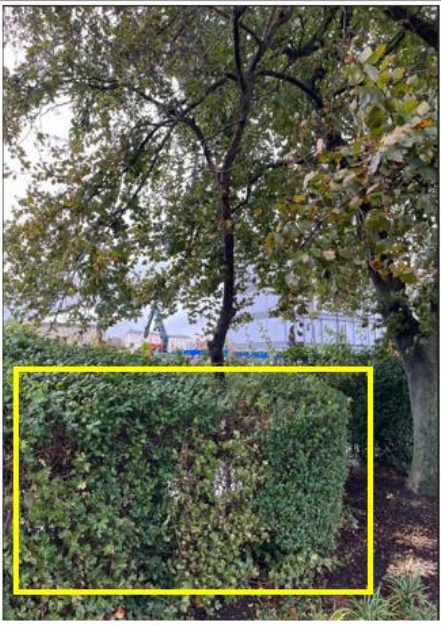
Description	Photograph
<p>H001 – Mixed (Mainly <u>Pivot</u> and Field Maple)</p> <p>Category B – Providing moderate visual amenity value.</p> <p>Arboricultural Recommendation: Partial Removal (approximately 3m)</p>

H001: Removal of an approximate 3m section of the hedge.
